Port of Ashburton – Blockage of seawater cooling strainers by crustaceans

Number: A14/2024

Date: 18/12/2024

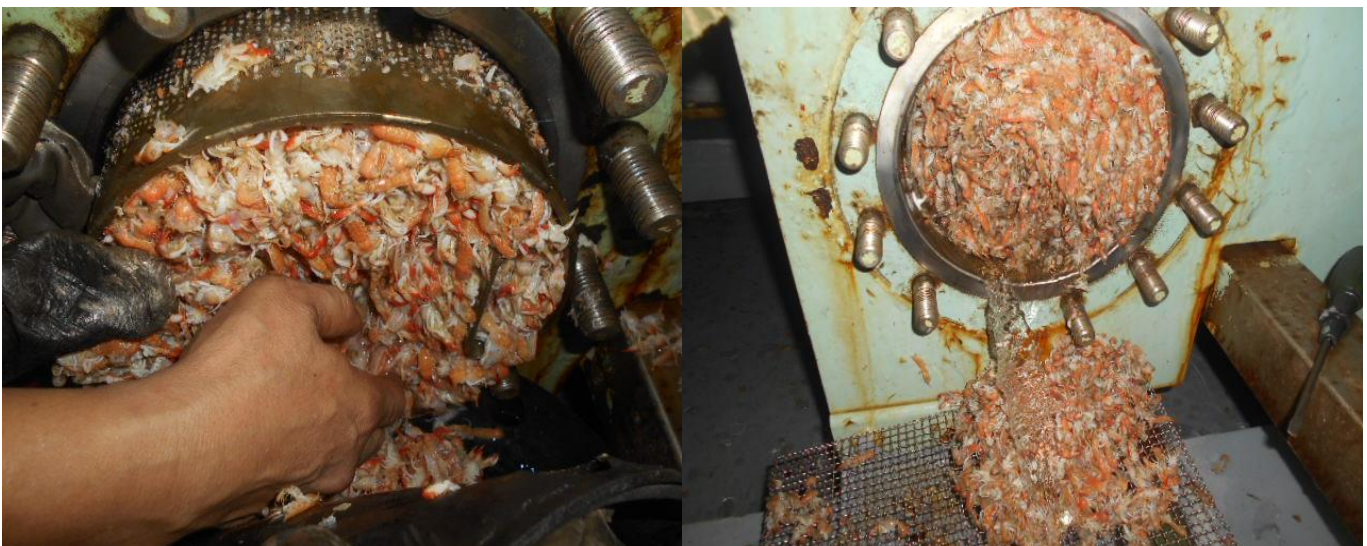
Mariners are advised that there is an upward trend of cooling related main engine slowdowns due to blockage of seawater strainers. Currently a mass spawning of crustaceans gathering under ships in the Western Anchorages being drawn into ships cooling water intakes.

Masters are advised to ensure that their seawater strainers are inspected and cleared before commencing an inbound pilotage.
