# Port of Dampier

## Blockage of seawater cooling strainers by crustaceans

Number: D29/2024

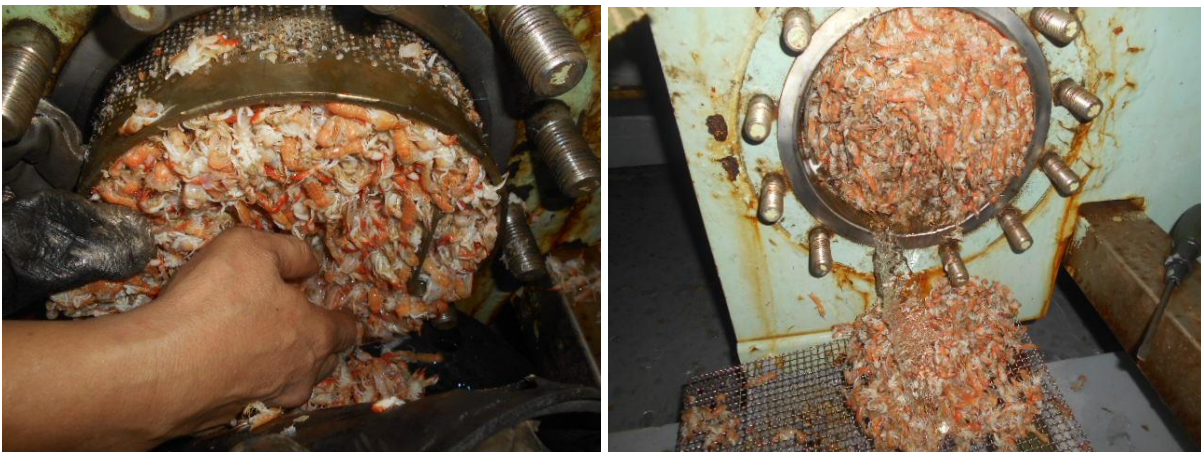
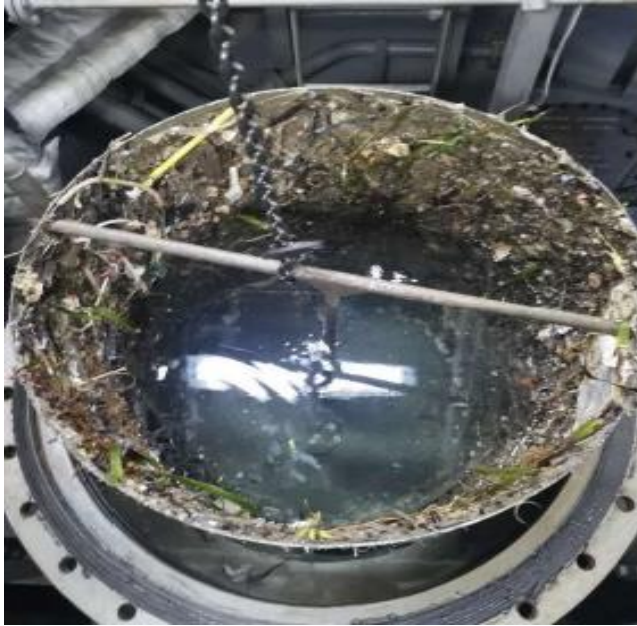
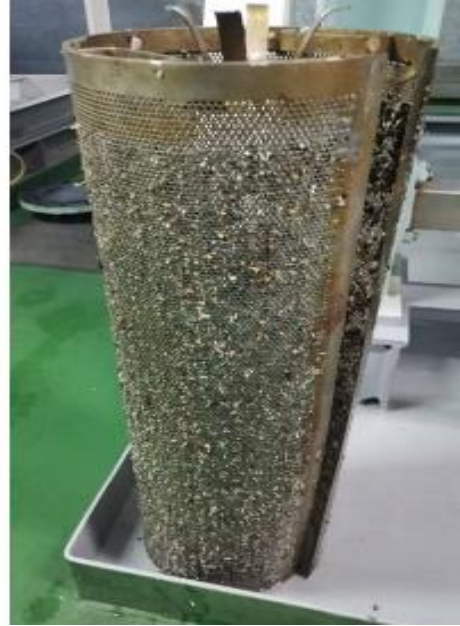
Mariners are advised that there is an upward trend of cooling related main engine slowdowns due to blockage of seawater strainers. Currently a mass spawning of crustaceans gathering under ships in the Western Anchorages being drawn into ships cooling water intakes.

Masters are advised to ensure that their seawater strainers are inspected and cleared before commencing an inbound pilotage.

- Detailed procedure for cleaning seawater strainers including black flushing, changing and cleaning is provided.
- Spare filters, all tools and equipment for opening the sea chest and cleaning is readily available.
- All Engineering staff is familiar with contingency plans.
- Monitor pressure at pumps and filters during the pilotage and respond without delay.
